**Lummi Nation Wetland and Habitat Mitigation Bank  
2014 (Year 3) Monitoring Report for 2011 Enhancement Areas  
Phase 1A Nooksack Delta Site**

**October 2015**

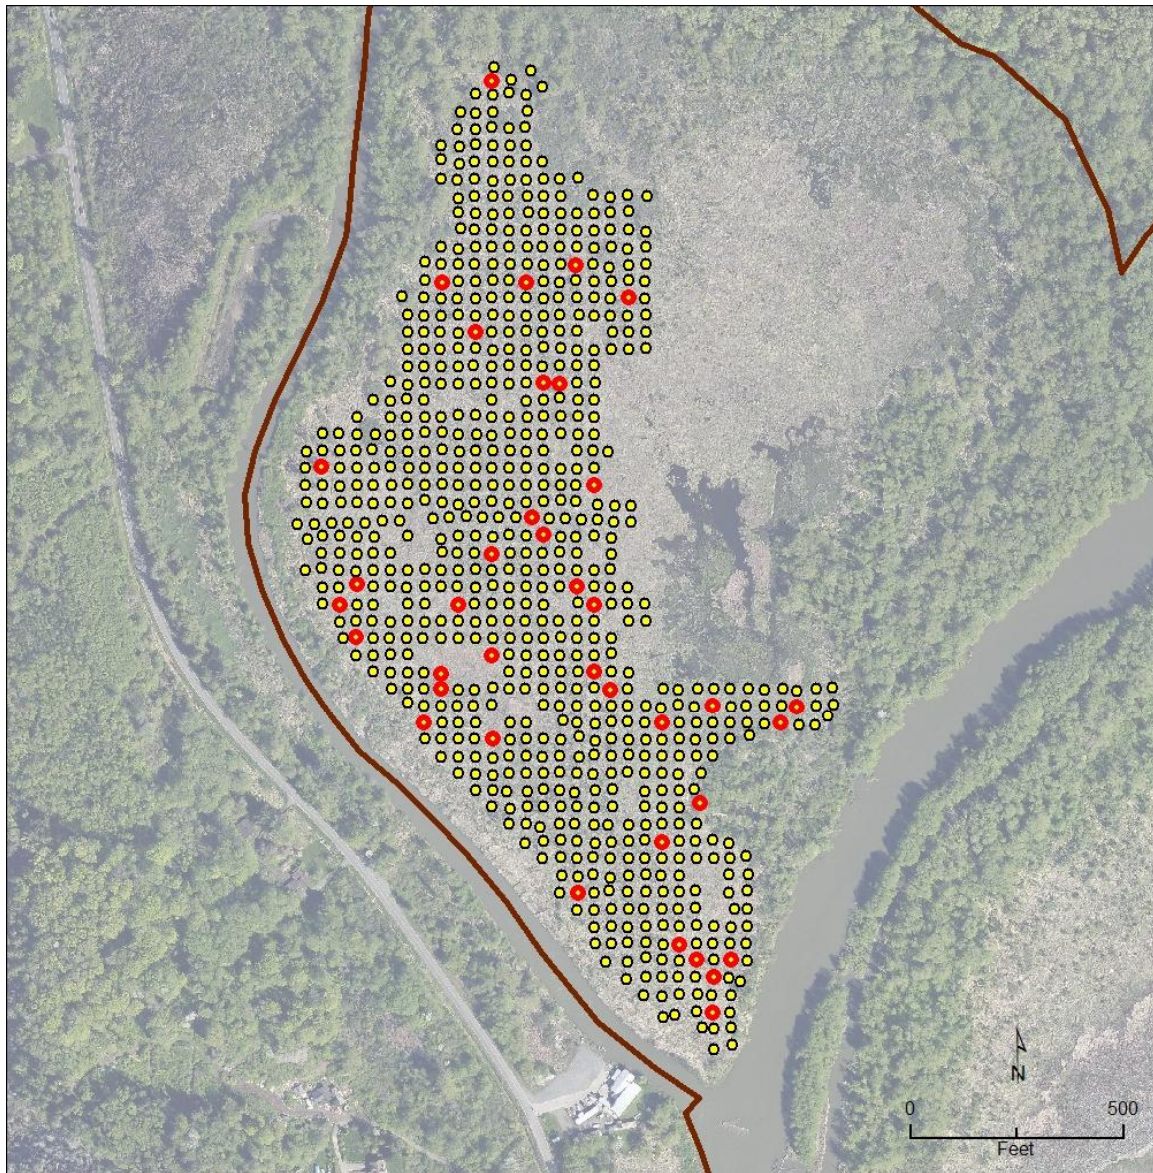
**Figure 2. 2011 Reed Canarygrass/Yellow Flag Iris Treatment and Willow Plantings Monitored during 2014**

Monitoring of the willow patches was conducted at 38 randomly selected plots covering 5% of the total number of plots. Plots selected for sampling are shown in red in Figure 2. Five photographs were taken at each sample plot during 2011, 2012, and 2014 to

Results of the aerial coverage estimates are shown in Table 3. Shrub cover was estimated to average 37.7% with a standard error (SE) of 2.4 over the 38 plots monitored at the end of the Year 3 (2014) growing season. The average coverage provided by native shrubs over all 38 sample plots increased from 13.7% (SE 1.2) in Year 0 to 37.7% (SE 2.4) in Year 3. The 37.7% cover estimate exceeds the performance standard of 20% by Year 3 as described in the MBI.

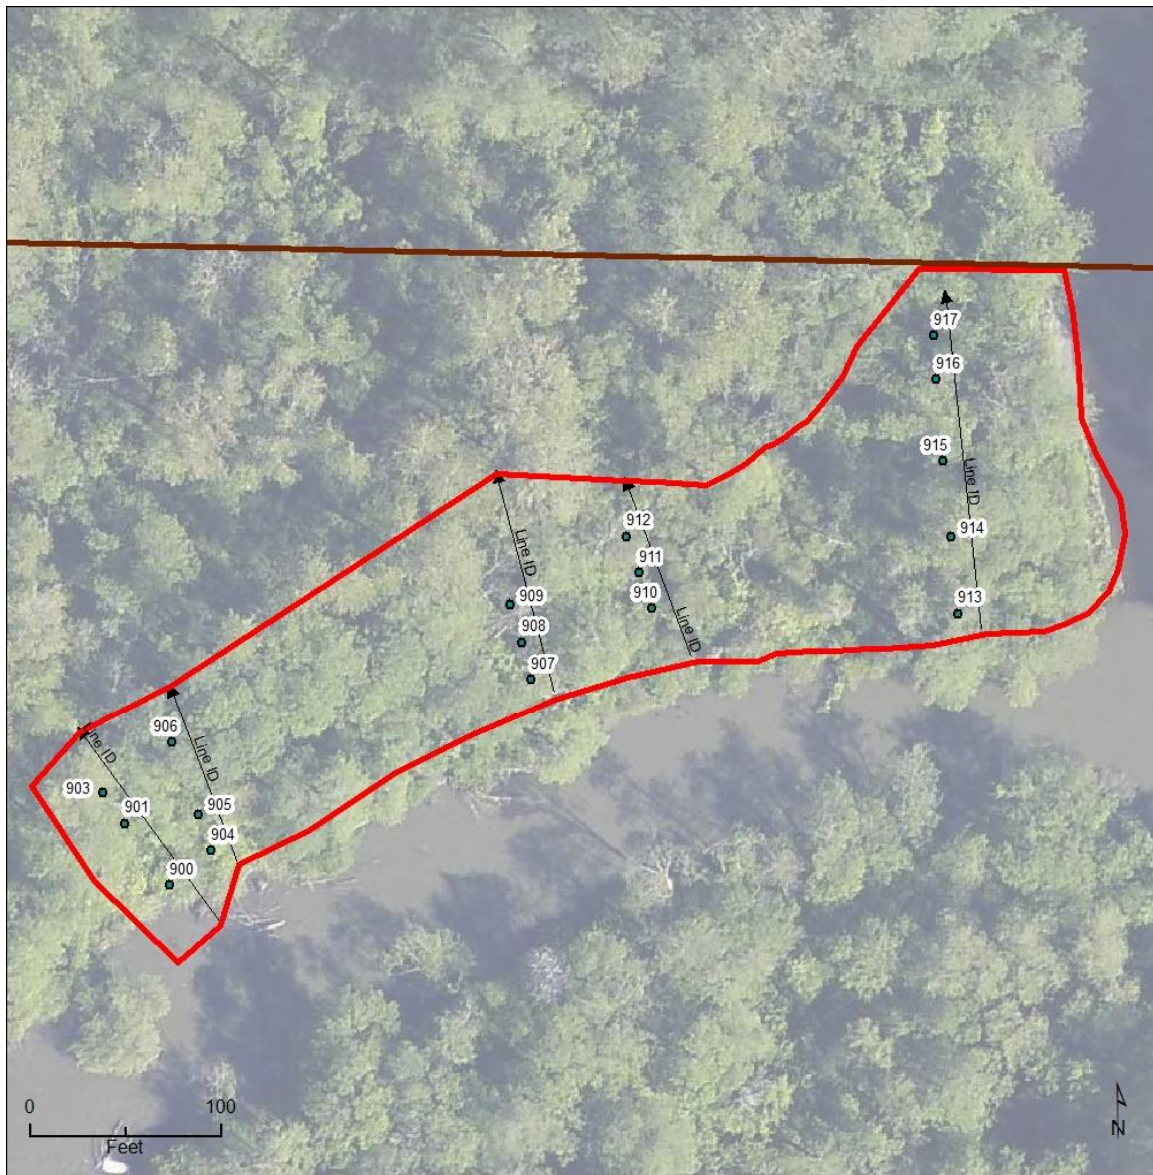
**Figure 3. 2011 English Ivy Removal Area, Monitoring Transect Locations and Monitored Plots during 2014**

The perimeter of the English ivy infestation area was surveyed with a GPS unit during 2011 to aid with maintenance and monitoring. Randomly placed transects were set up and monitored in 2011 within the ivy infestation area to measure the baseline condition before treatment (Figure 3). Line intercept sampling was conducted along the transects and visual estimates of ivy cover were made within 10-foot diameter plots adjacent to the transects. Pre-treatment monitoring showed that average ivy cover was 30.4% (SE 8.9) in the sample plots and 42.7% (SE 28.7) along line intercept transects. A detailed summary of the ivy monitoring for each transect and plot is shown in Table 5.

As shown in Table 5, Performance Standard 3B was achieved by Year 3. However, additional ivy removal measures appear to be necessary if the areal coverage of English Ivy is to be reduced below 30% by Year 5 (Performance Standard 3C).

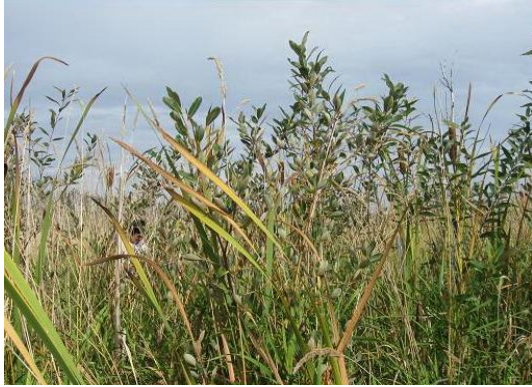
Station Identifier	Image
WP014

(Photographs taken in September 2014 from south end of sample plots facing north and show willows planted during 2011.)

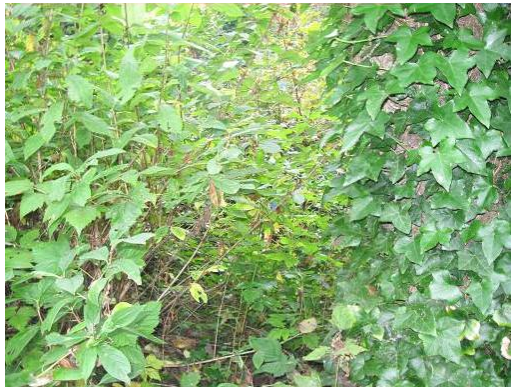
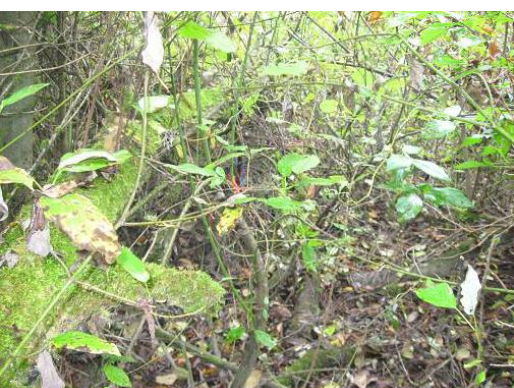
(Photographs taken on October 10, 2014 of Ivy Treatment Area Monitoring Plots)
